9 Volunteer Fire Fighters and 1 Off-Duty Career Fire Captain Killed by an Ammonium Nitrate Explosion at a Fertilizer Plant Fire – Texas

November 12, 2014

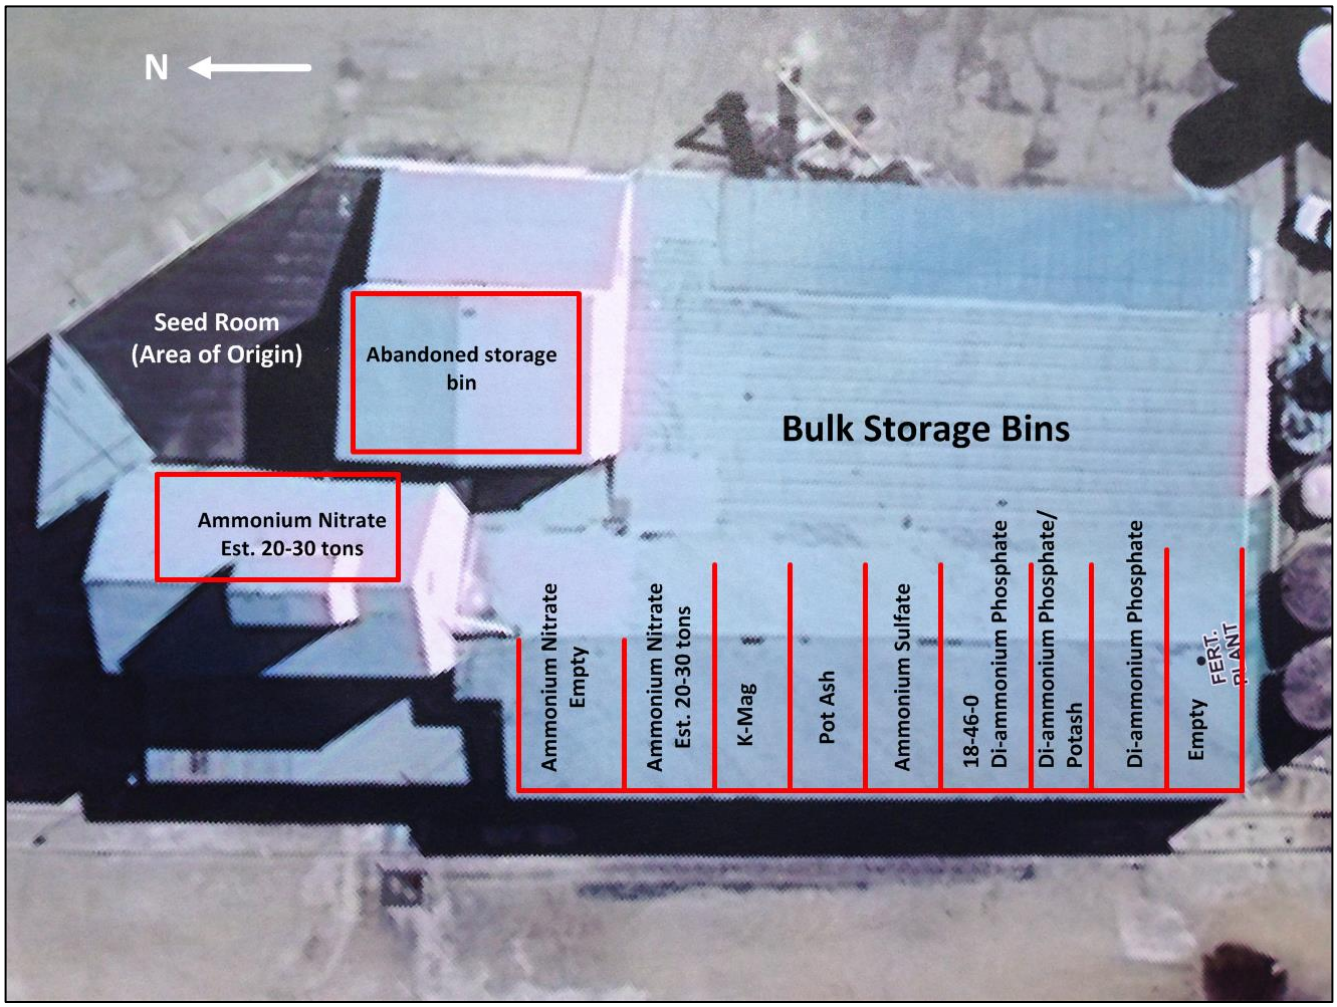
Photo 3. Overhead view of fire building showing the approximate locations of the storage bins that contained the bulk dry fertilizer materials. The seed room is believed to be the room of origin.
(Adapted from ATF Diagram)

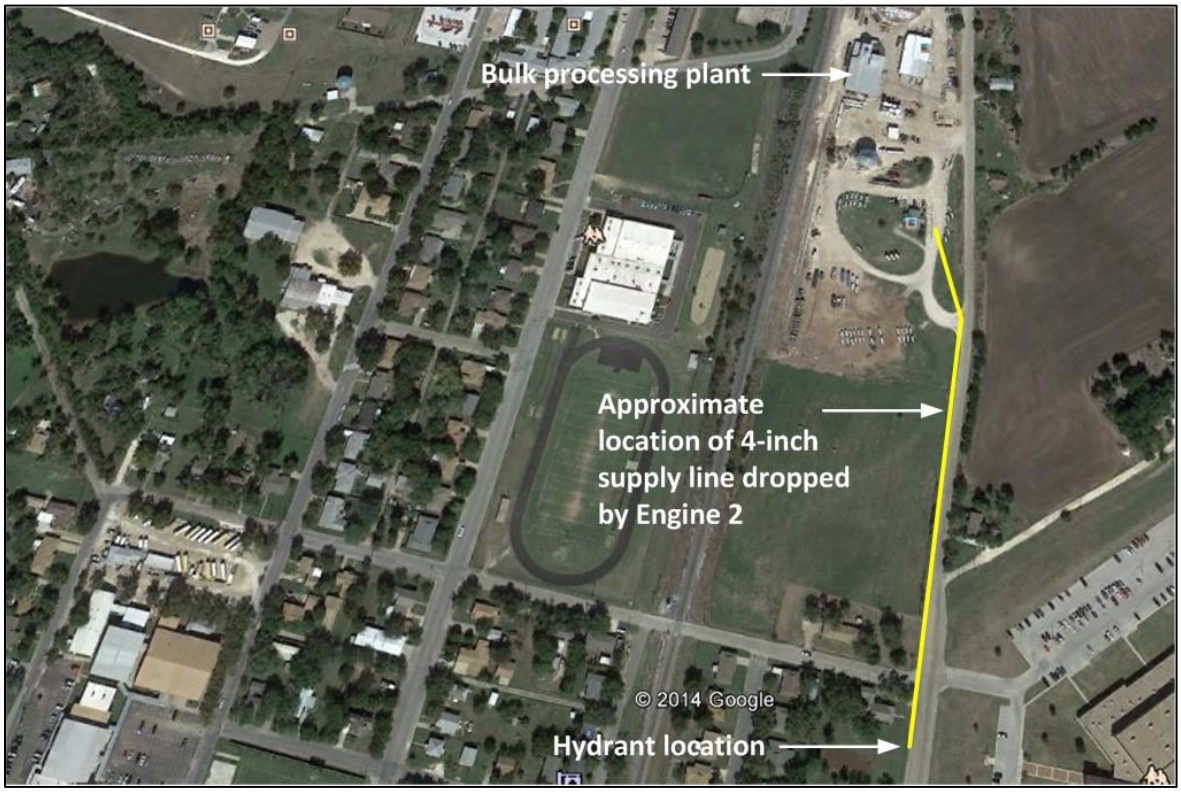
Figure 2. Approximate location of 4-inch supply line dropped by Engine 2.
(Figure adapted from Google Earth satellite image. Imagery date 10/2012.)
